## October 26, 2018 - Tomahawk Cleans and Lines Watermains in Sherbrooke, Quebec

**Location:** Rues Blanchard and Brouillette, Sherbrooke, Quebec

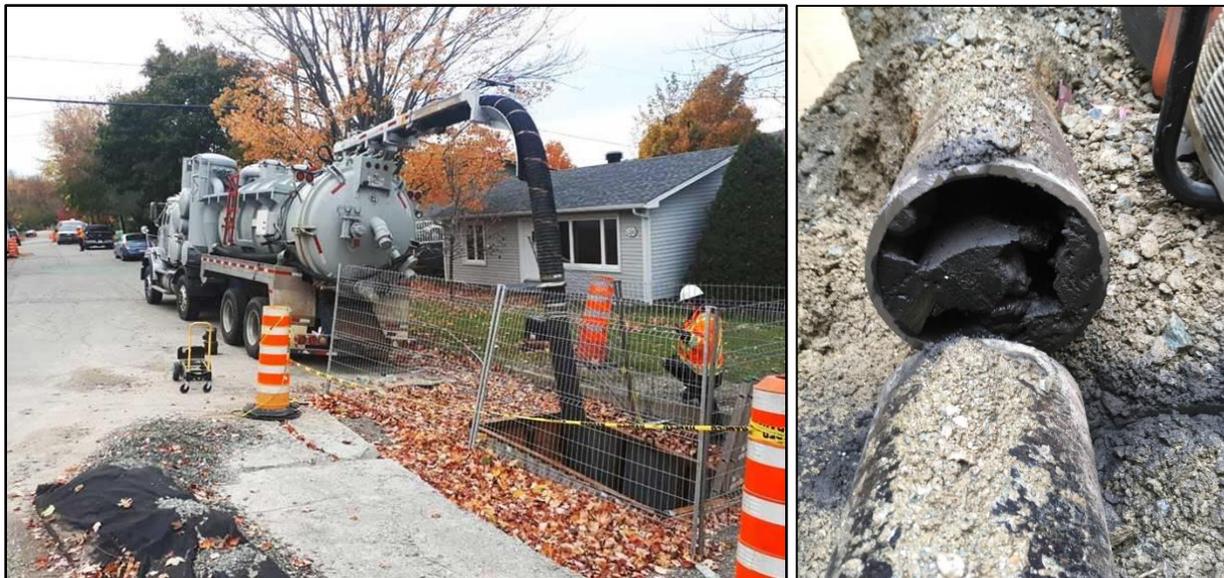
This project contained 500m of 150mm (6") ductile iron pipe on two residential streets. The pipes were highly tuberculated resulting in very low pressure, flow rates and chlorine residuals.

Pictures: Above left, cleaning and lining watermains in Sherbrooke, Quebec. Above right, initial internal condition of highly restricted, low flow watermain.

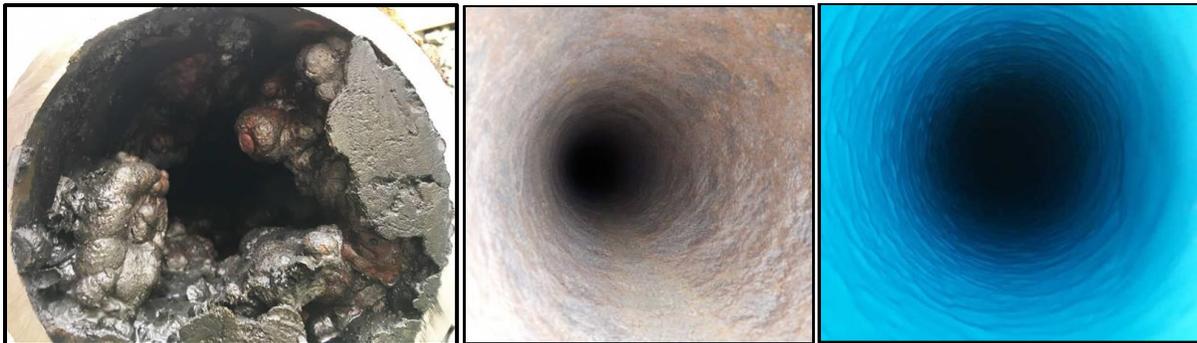
Pictures: Above left, watermain before cleaning, center, after cleaning with Tomahawk, right, after lining with Tomahawk BluKote™.

**Results:** The residents on these streets are now enjoying renewed water flow rates and pressure. The C-factor improved from a low of 15 to a high of 111, representing a 755% improvement. Chlorine residuals also improved resulting in higher quality drinking water. The pipe's useable life has been extended by decades.
