Watermain Cleaning, and Preparation

Innovative Solution for Water Utility Owners

Tomahawk™ System

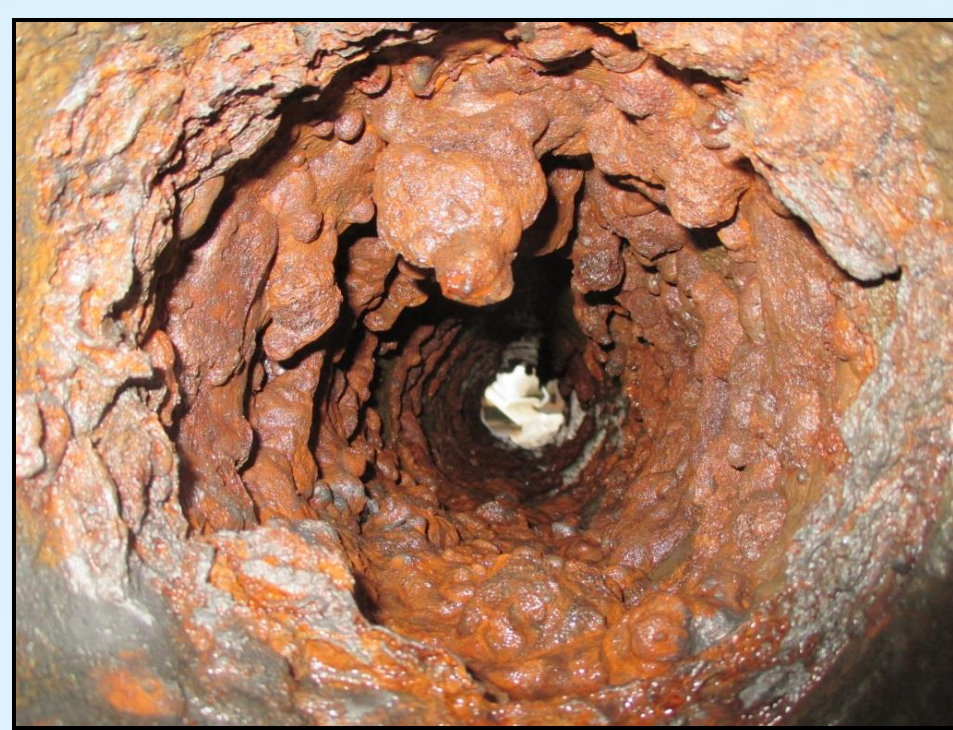
6" tuberculated water main. Photo by Envirolitics

These aging, deteriorated pipes are often congested with deposits, leaking and too often...failing!

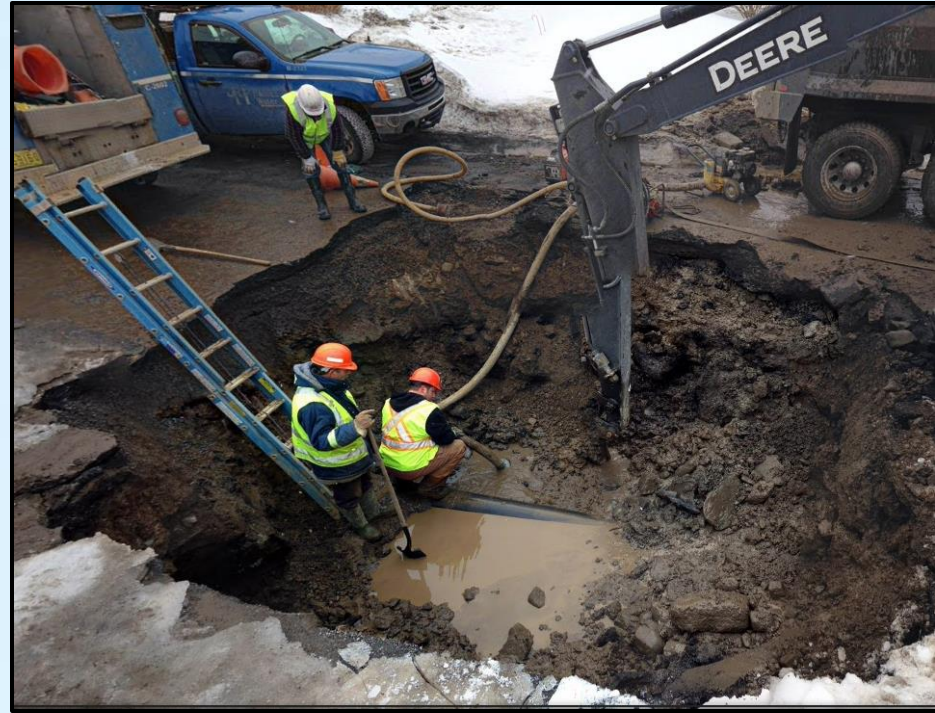
Water main break and repair. Source: Google Maps

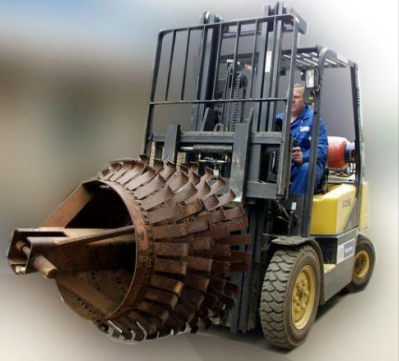
Drag Scrape

- Can foul thousands of gallons of clean water and may require containment and treatment depending on contents
- May not remove all deposits, corrosion and bitumen to fully expose pipe wall
- Leave the pipe wet
- Further surface preparation is required to meet ASTM F3182

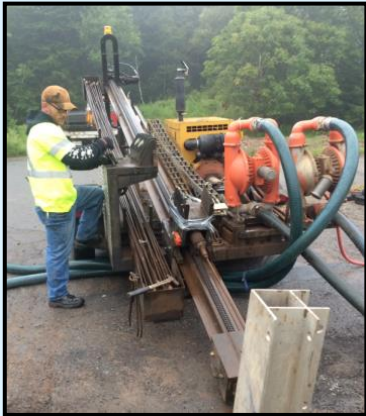
Power Bore

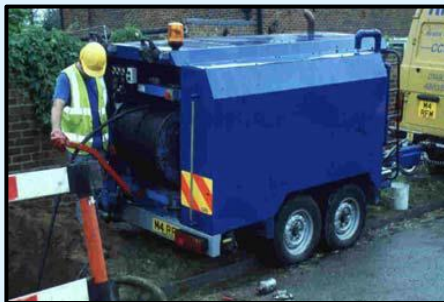
Water Jet

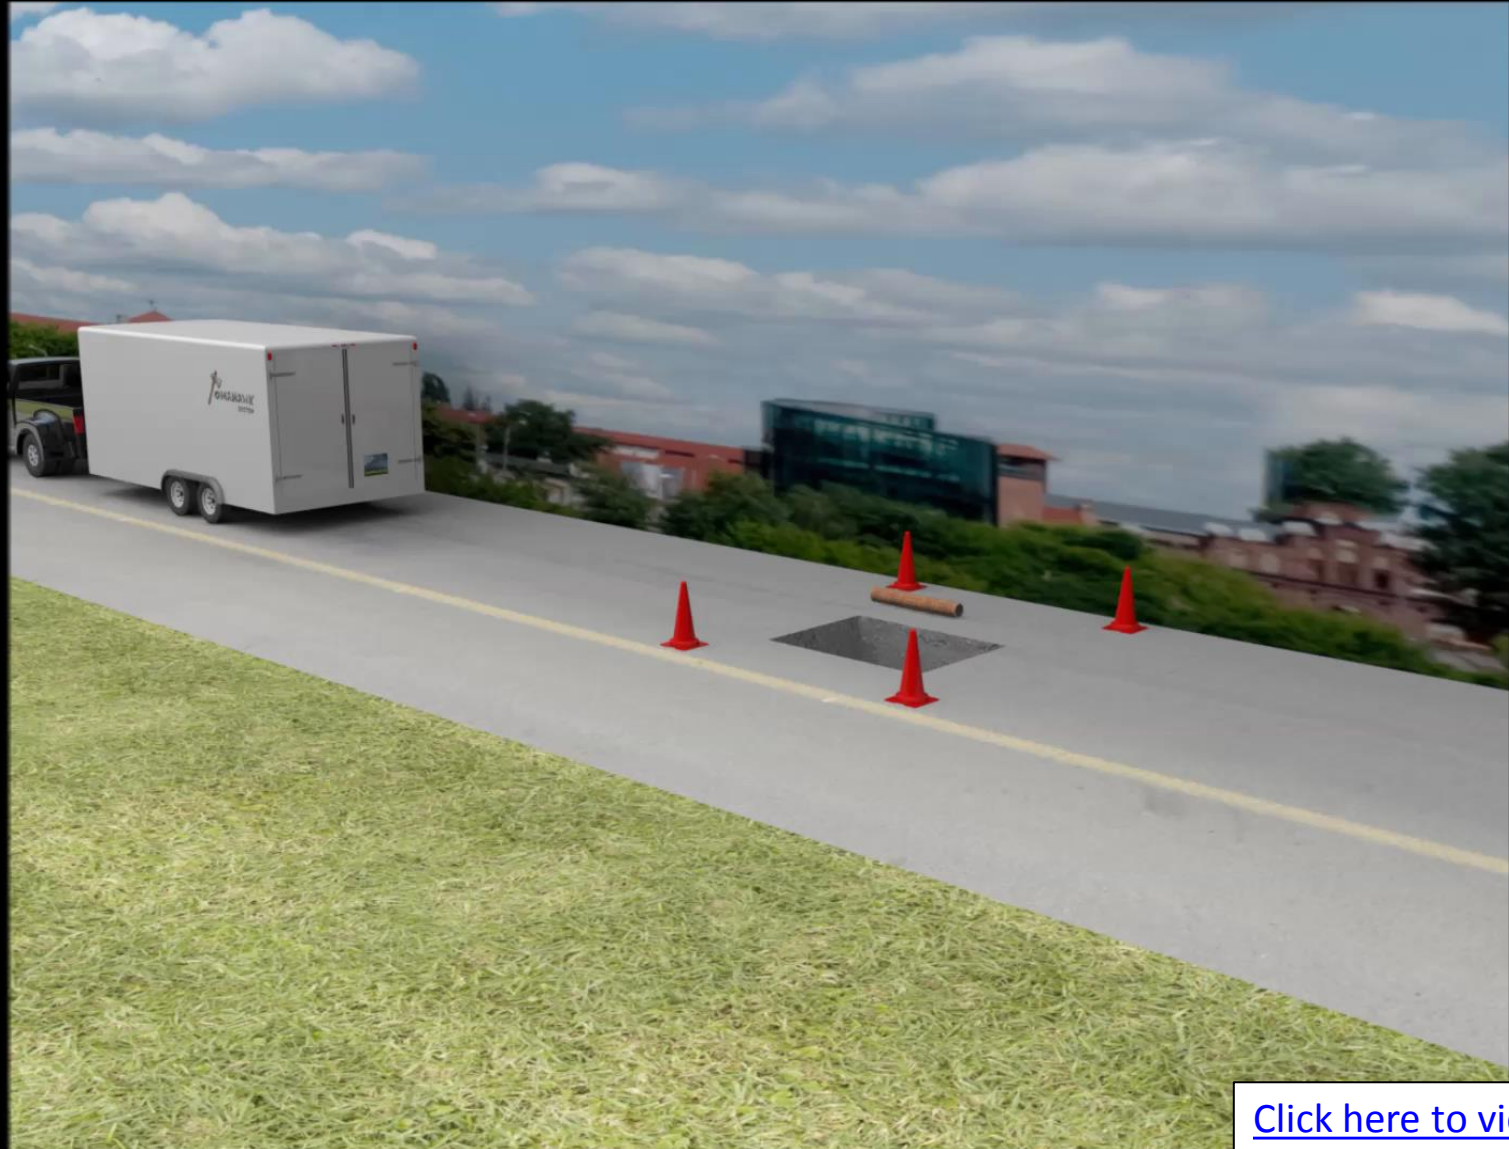
Tomahawk™ System Process Overview

Patented Tomahawk™ System
Aggregate Delivery Unit

Standard Vacuum Truck

In-ground water main
up to 450' long

The Tomahawk™ System restores deteriorated pipes using abrasives and a high-volume, low-pressure airstream to clean and dry the pipe in preparation for lining using minimal to no water.

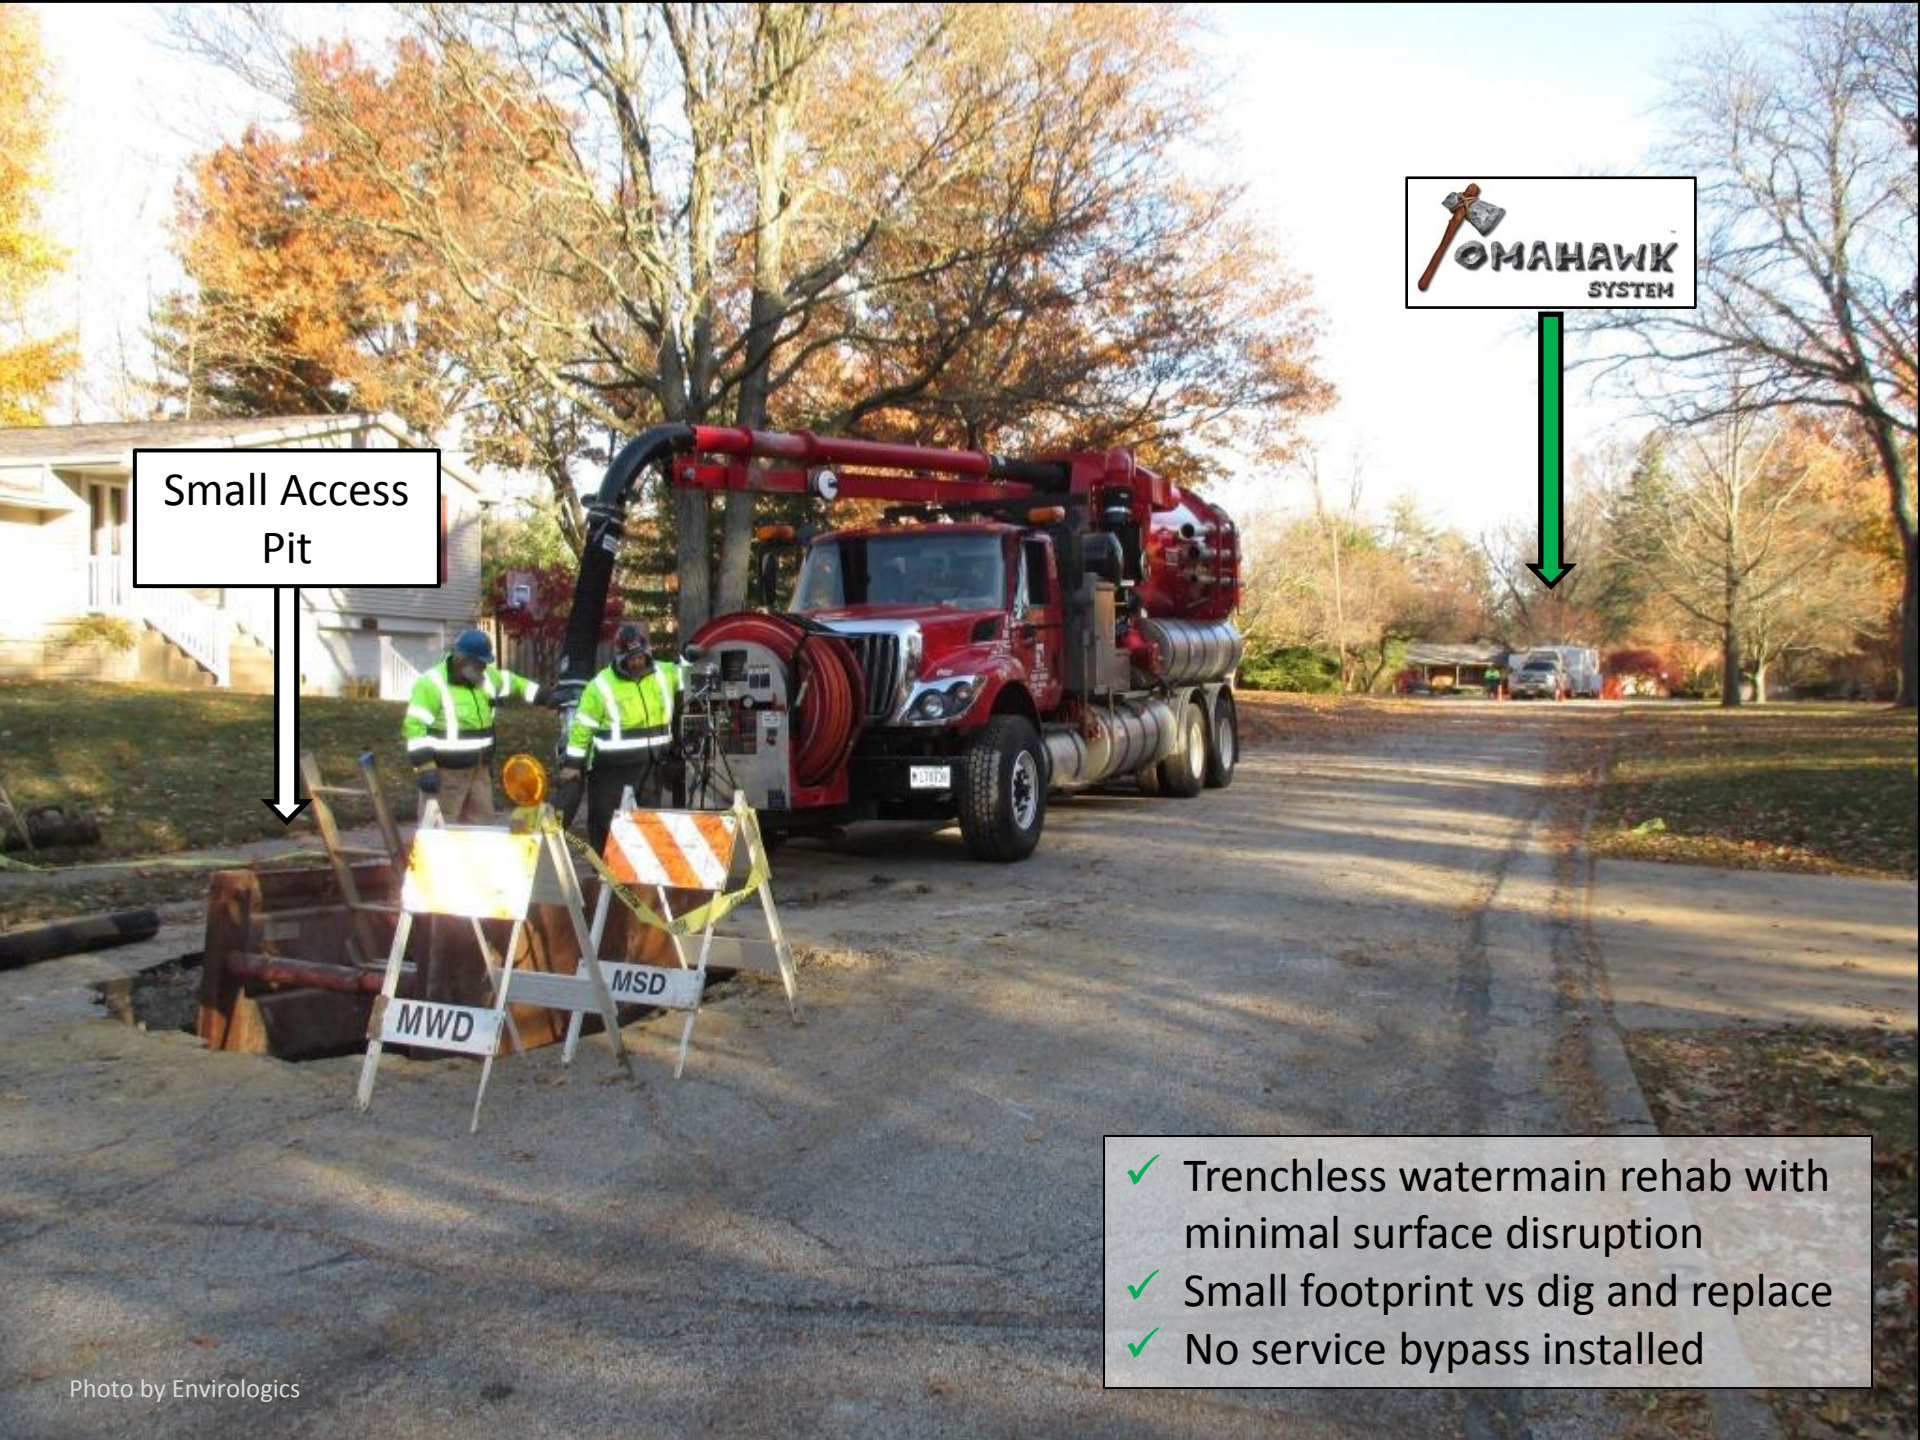
Small Access
Pit

- ✓ Trenchless watermain rehab with minimal surface disruption
- ✓ Small footprint vs dig and replace
- ✓ No service bypass installed

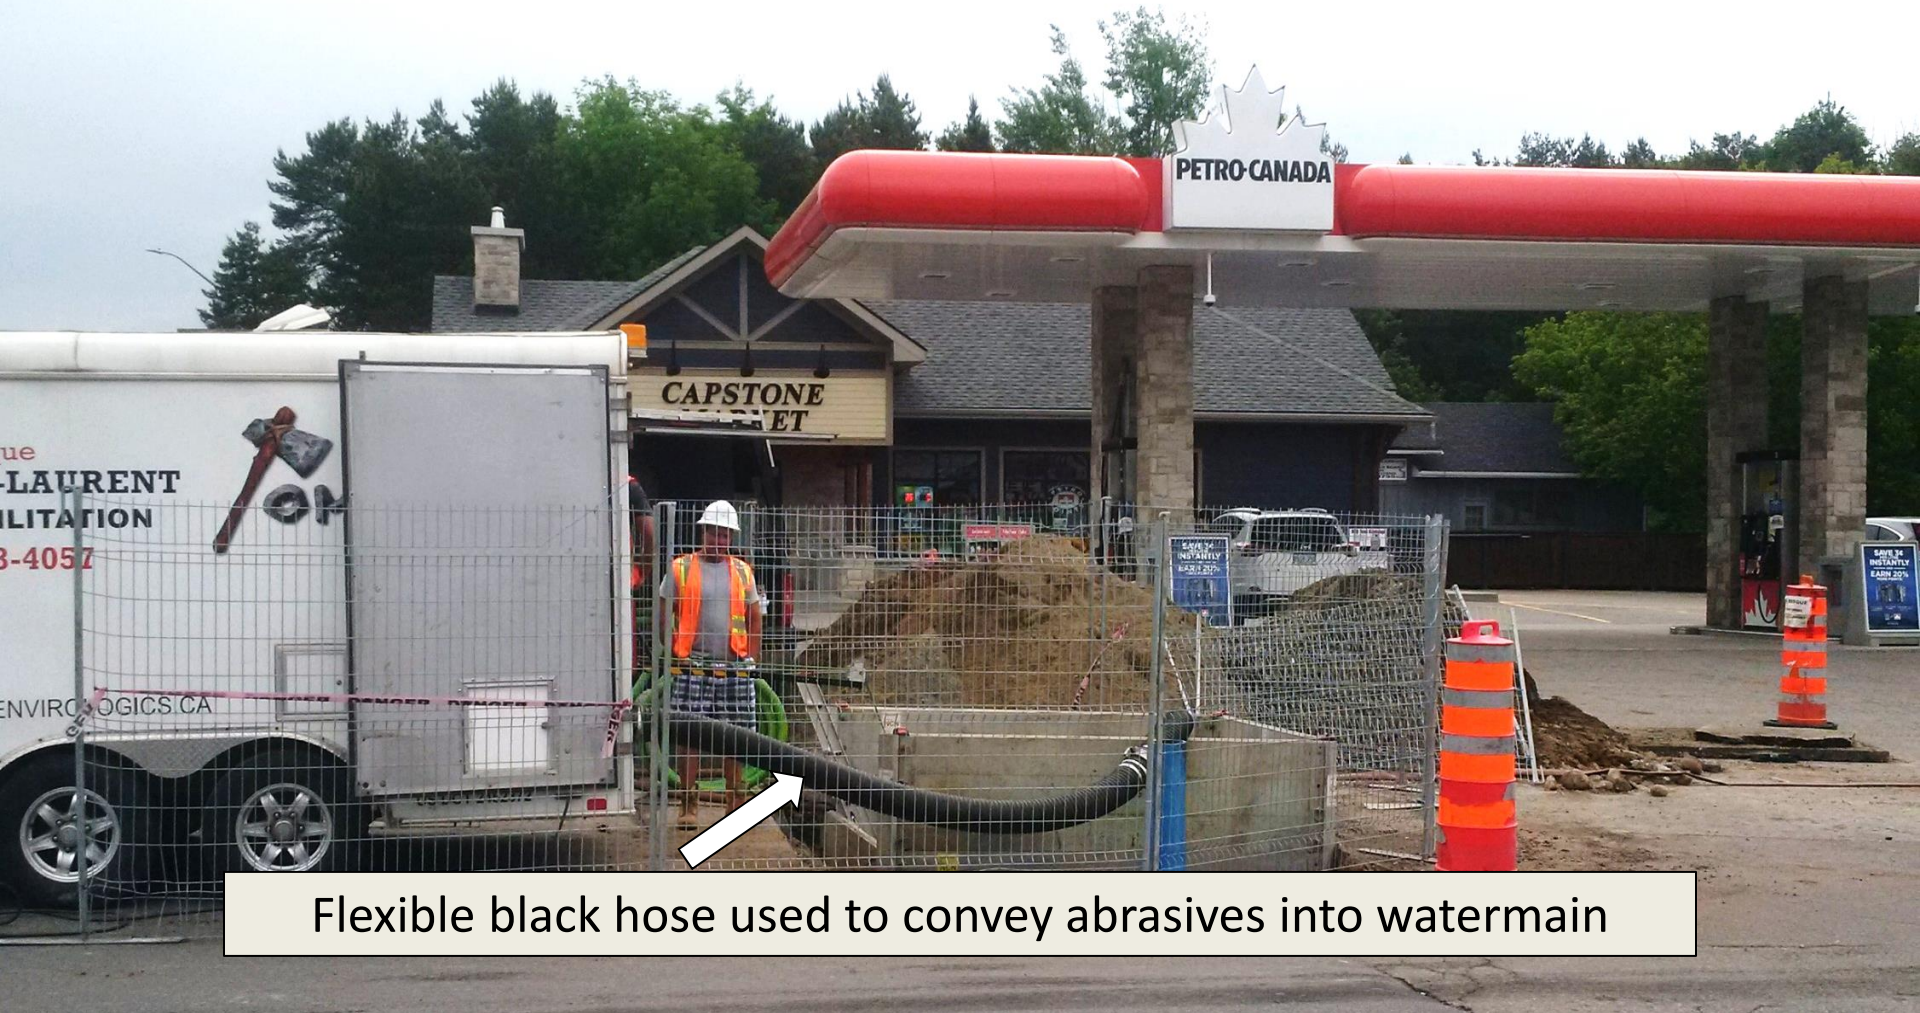
Aggregate delivery trailer

Flexible black hose used to convey abrasives into watermain

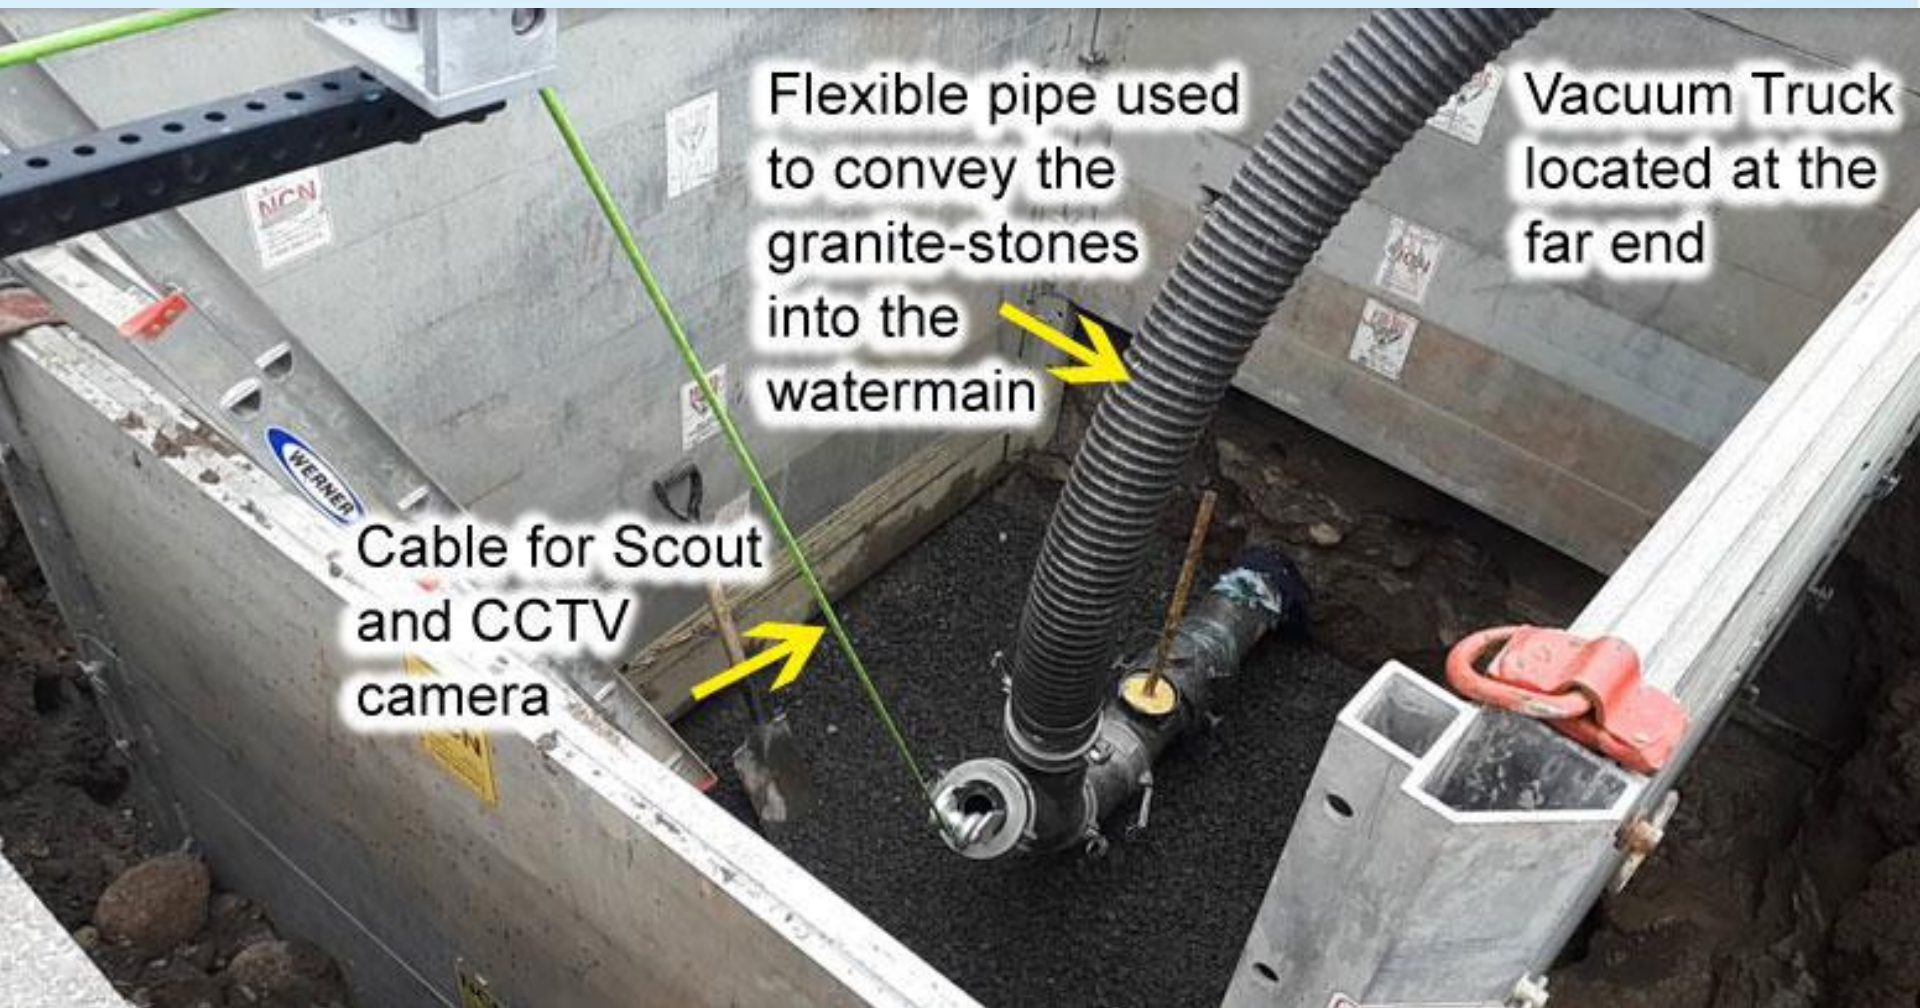
Set-up in Access Pit

Vacuum truck connected to pipe at far end

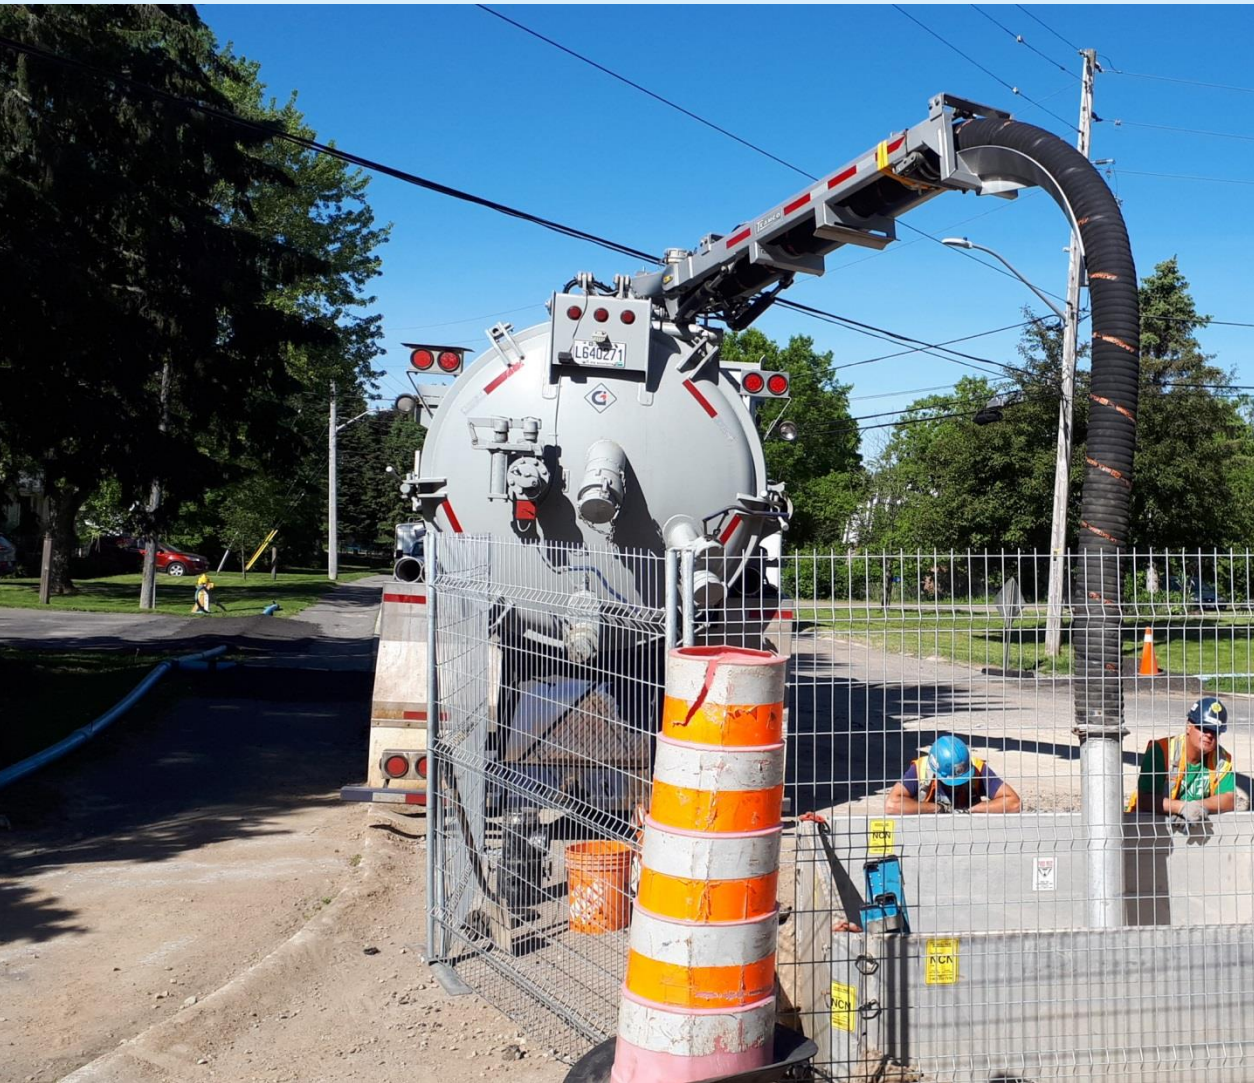
Vac truck

- Generates pipe airstream for cleaning process
- Captures dust and debris, maintaining a clean and safe worksite, protecting both public and workers
- Eliminates public viewing of the nasty waste released from their drinking water pipes
- Allows for ease of disposal

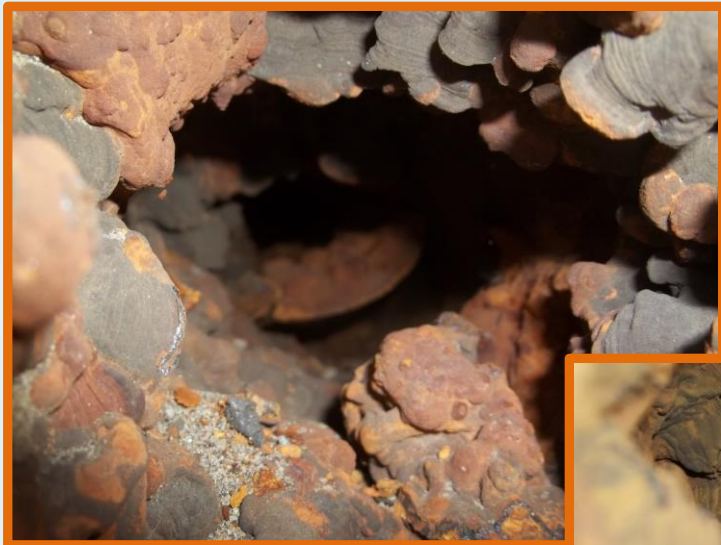
Tuberculation

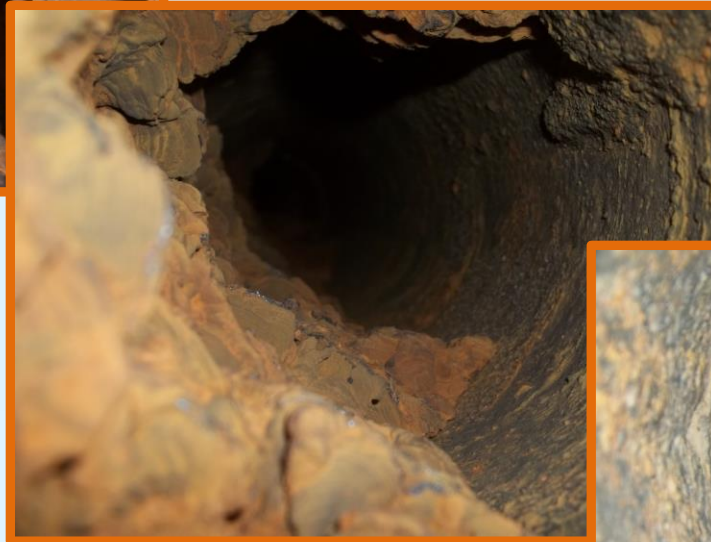
Partial tuberculation
removal

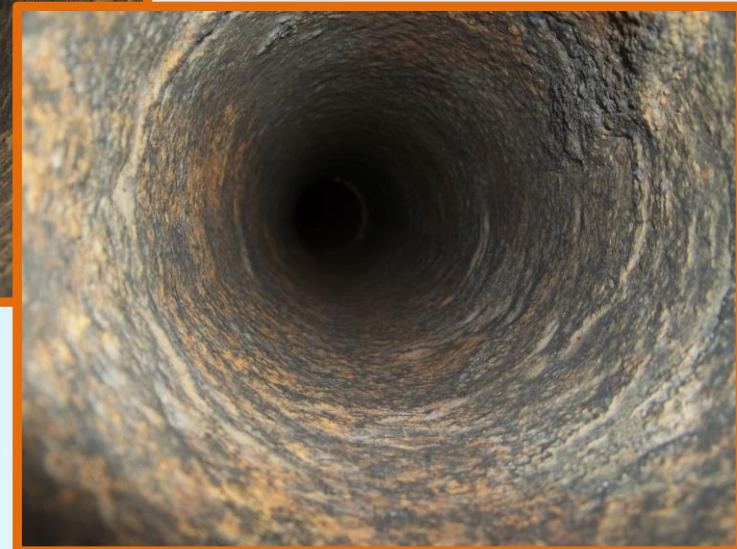
Full tuberculation removal,
bitumen liner visible

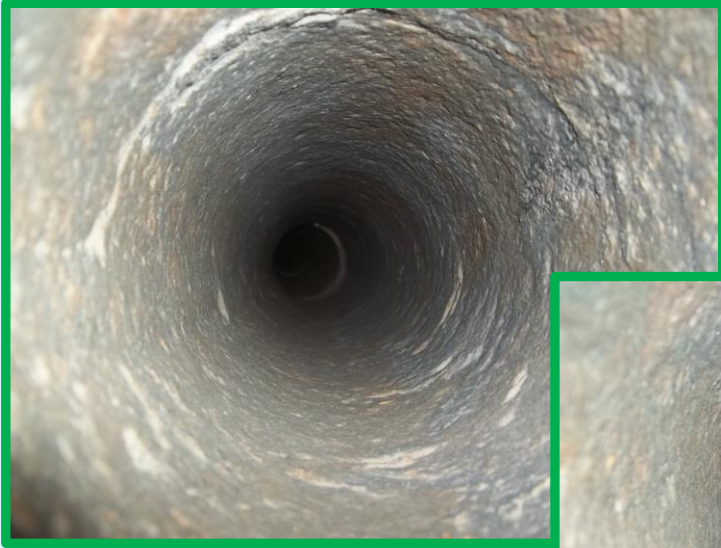
Bitumen liner being removed

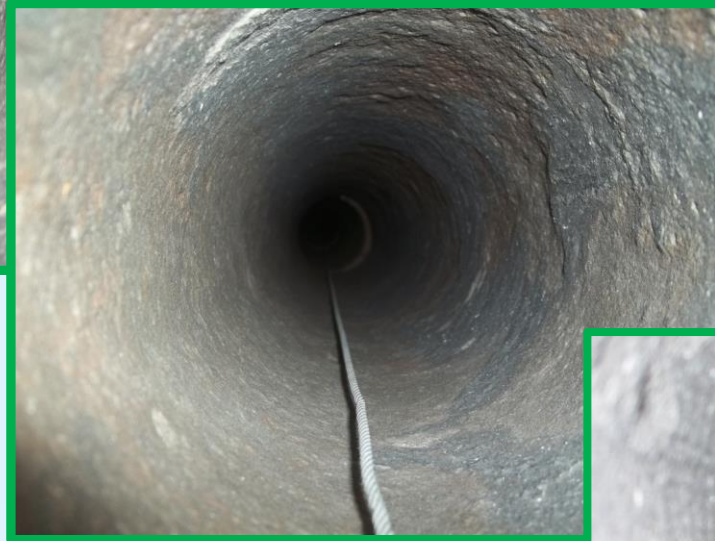
Partial liner and graphitic corrosion removal

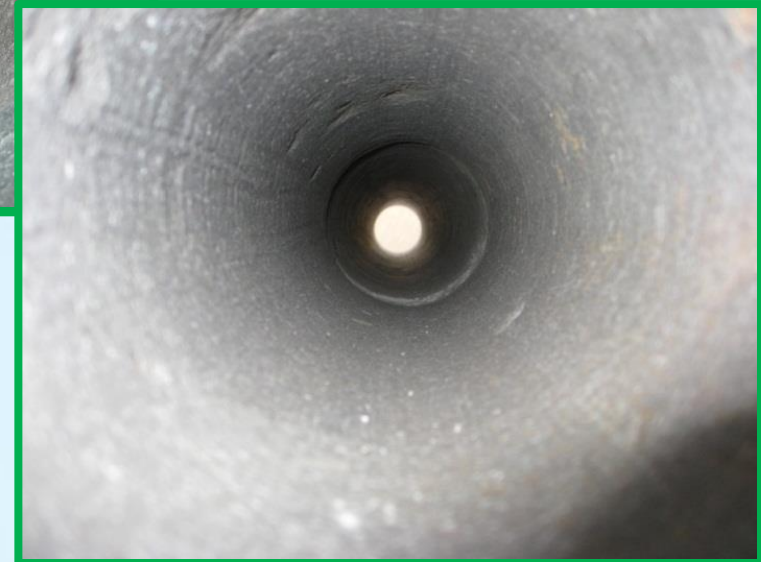
Fully prepared for liner bonding

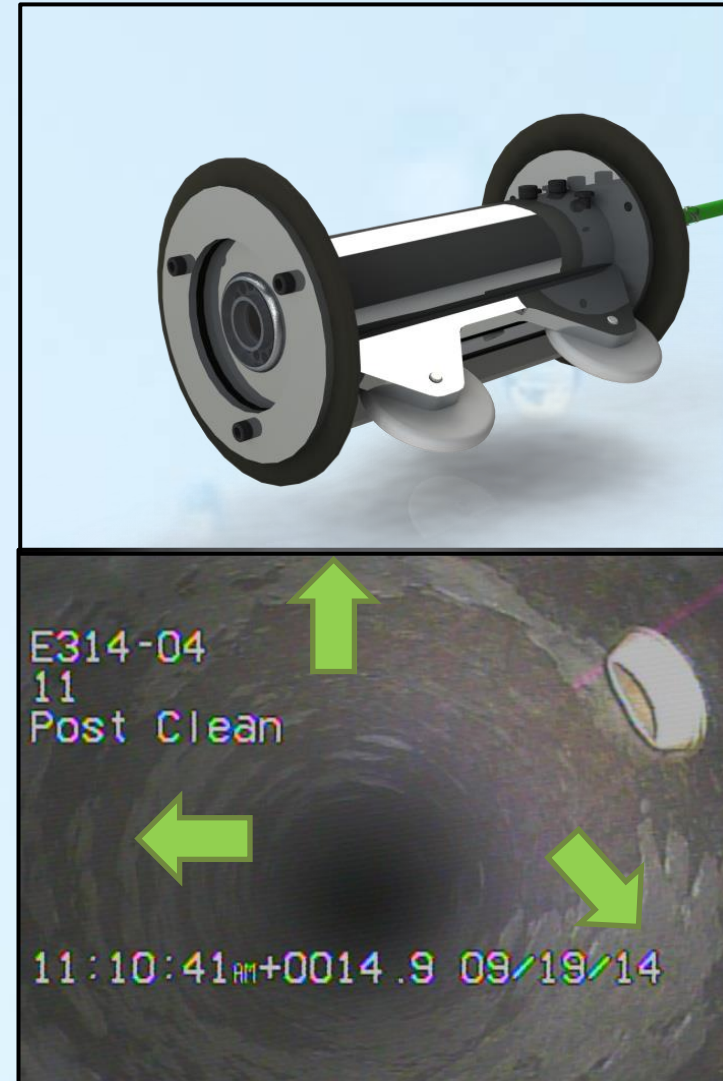
- Tomahawk Scout™, air driven CCTV inspection camera and vaculator, used during preparation
- The green arrows indicate where loose graphitic corrosion was removed
- Preparation meets or exceeds ASTM F3182
- Service connection was cleaned to an SSPC-SP6/NACE No. 3 condition for superior liner bond
- Scout videos can be viewed on our [Envirolitics YouTube](#) channel

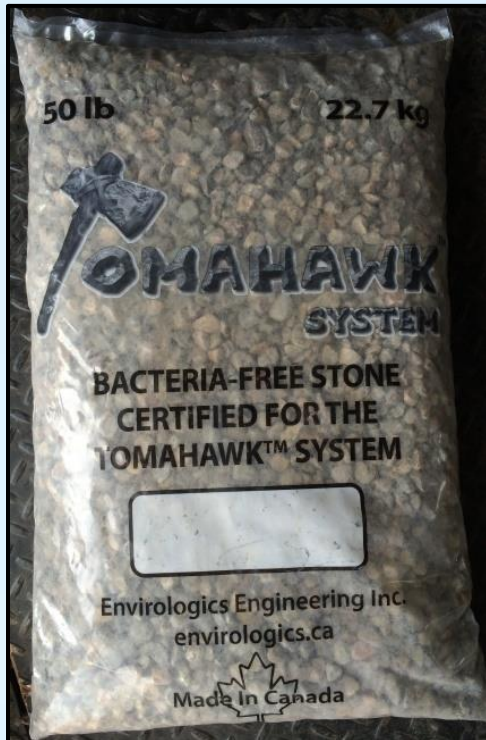
- Various sizes, 50lb bags
- Stone is clean and dried at high temperature
- Verified bacteria free

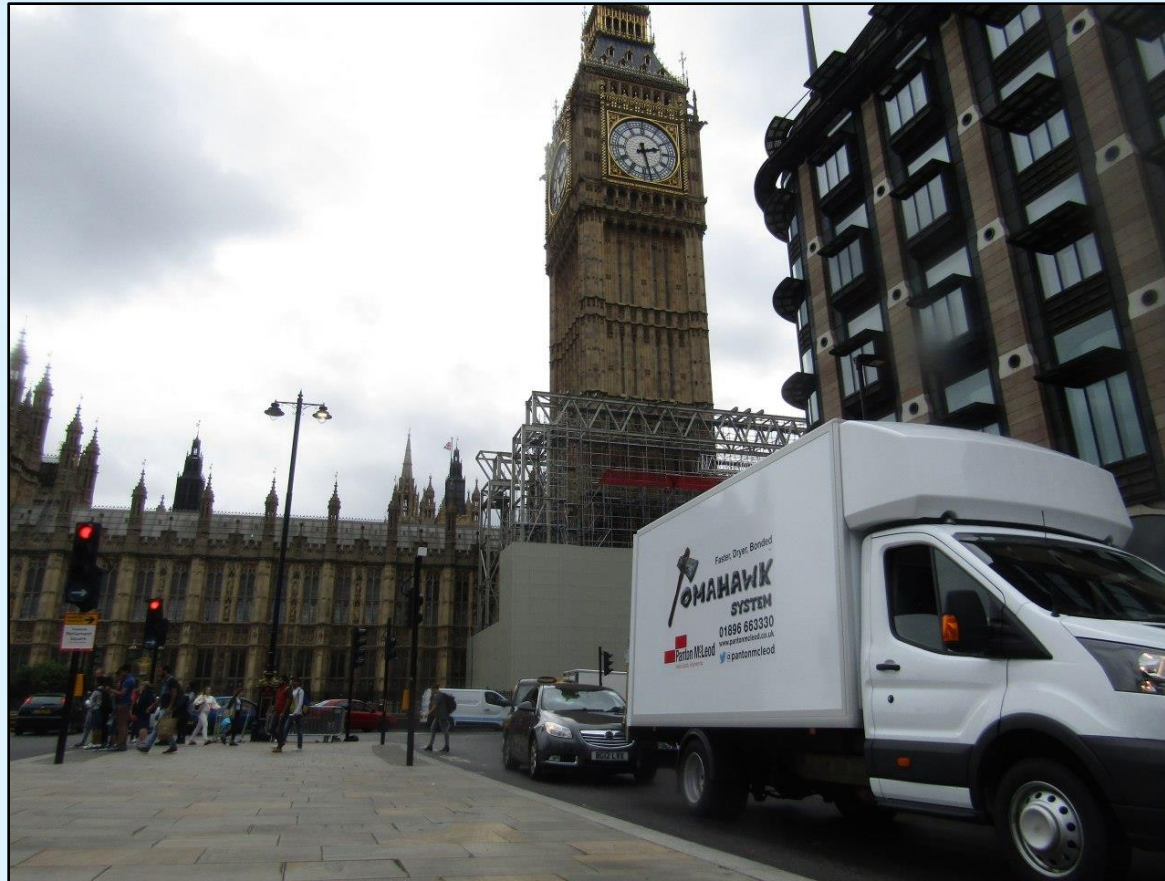
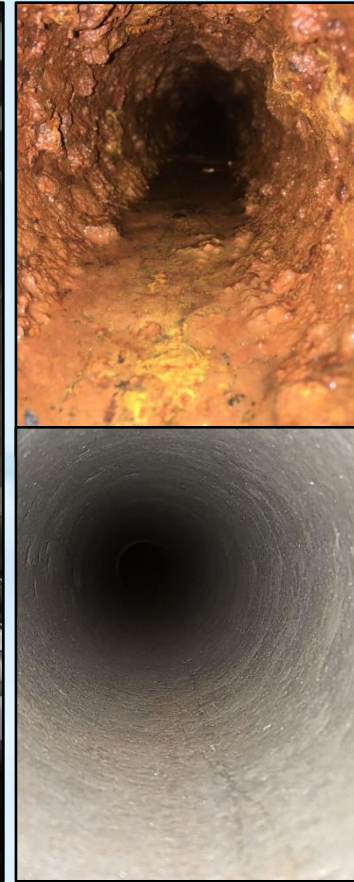
Cleaning Results: 4" Cast Iron Pipe Cleaned in London, England

- 1889 unlined cast Iron pipes
- Panton McLeod UK, Tomahawk licensee

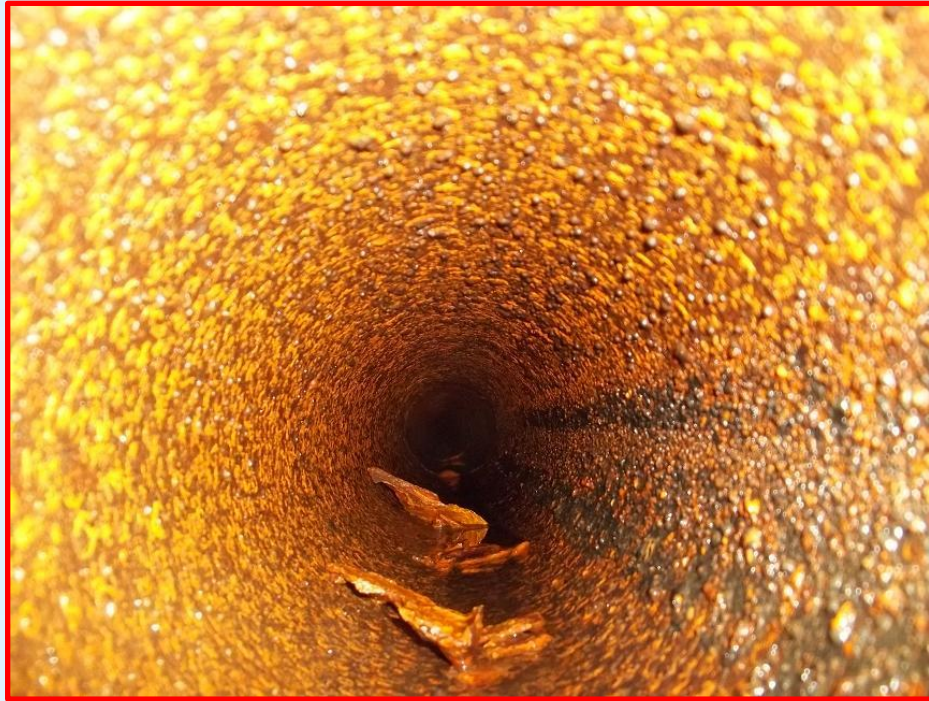
Before

Corrosion and Coal Tar Liner Removed from 6" Cast Iron Pipe

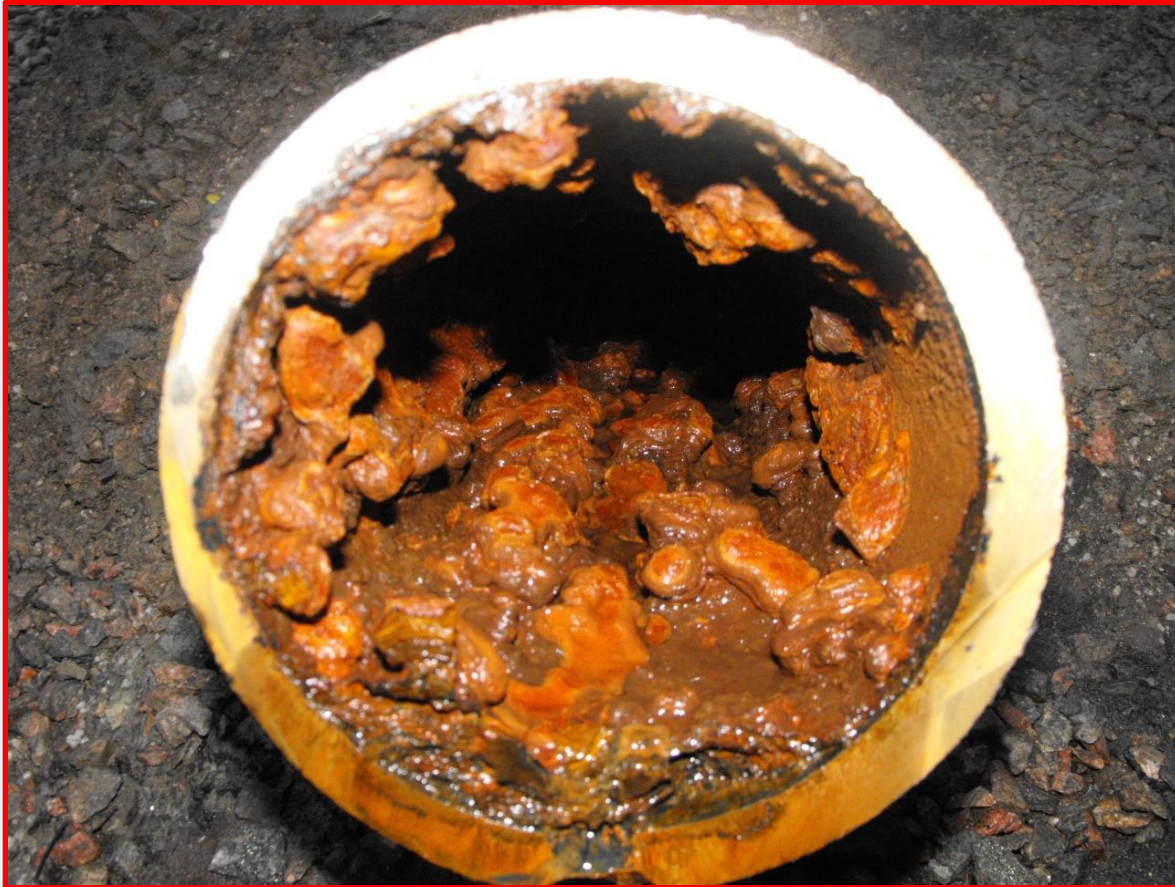
Before

Tuberculation Removed From 6" Unlined Cast Iron Pipe

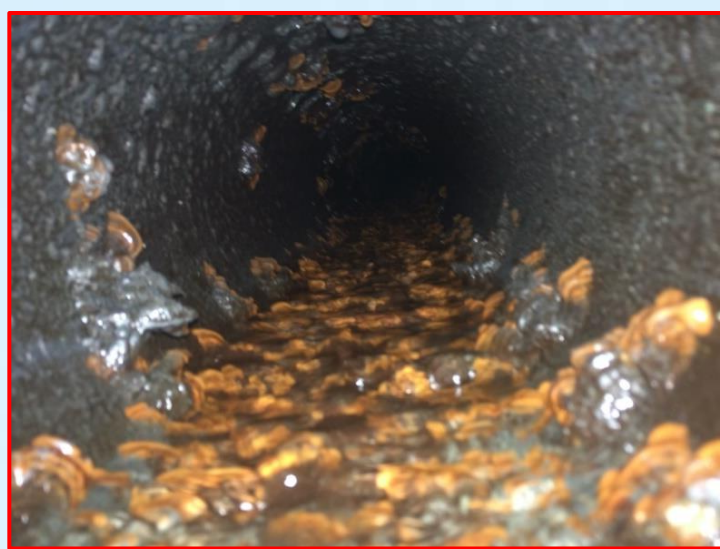
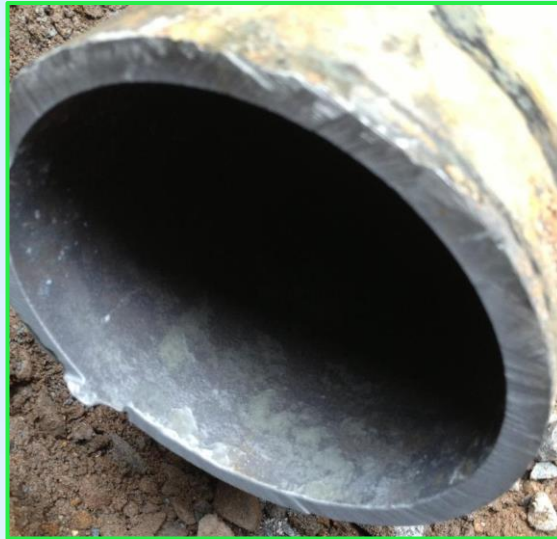
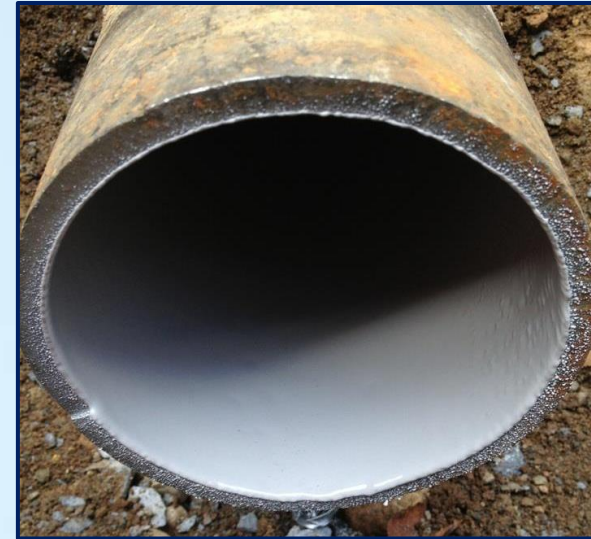
Saint John, NB: Bitumen and Tuberculation Removal

- Project completed July 2014
- Objective: Water quality/capacity improvement
- 800 meters of CI pipe rehabilitated in 6 days
- 150 mm (6") and 200 mm (8") bitumen lined
- 1955 cast iron pipe; structurally sound
- Same day return to service; no service bypass
- Water quality lining: 3M Scotchkote™ 2400 Liner applied by Trenchless Solutions Inc. of Moncton NB.

- Improved water quality
- Hydraulic capacity restored
- Reduced power consumption to pump water
- Decades of additional service

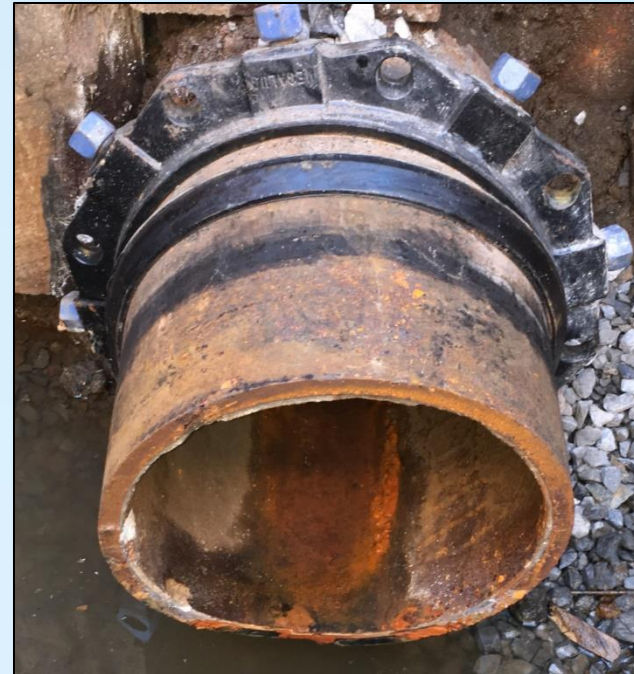
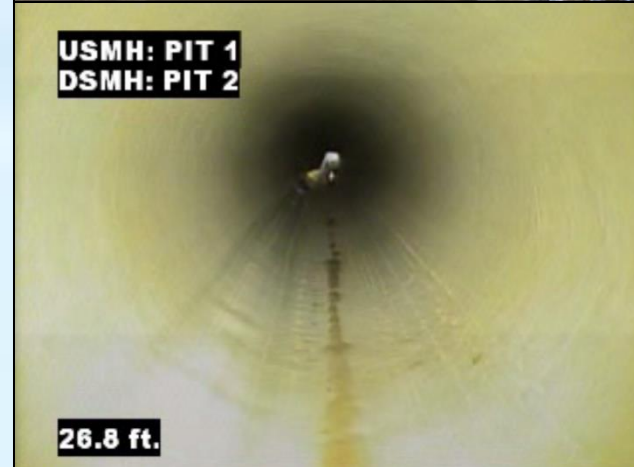
12" CML Pipe Cleaned and Prepared for CIPP Installation

- 12" CML pipe with leak located directly under an active railway line in New York City
- Due to critical location, pipe sat abandoned for 2 years awaiting a cleaning and preparation solution
- Tomahawk completed cleaning and preparation of pipe segment in one hour
- Removed biofilm, tuberculation at joints, and deteriorated CML providing a smooth and dry surface for ease of pulling in CIPP liner and achieving excellent bond to pipe
